LEAD-BASED PAINT PRESENT

Enclosed you will find the results of the Lead-Based Paint Inspection (utilizing an X-Ray Fluorescence Device) which was performed at the address mentioned above on Thursday, June 4, 2009. This inspection was targeted at the painted surfaces throughout the apartment.

Project #: 09-4289

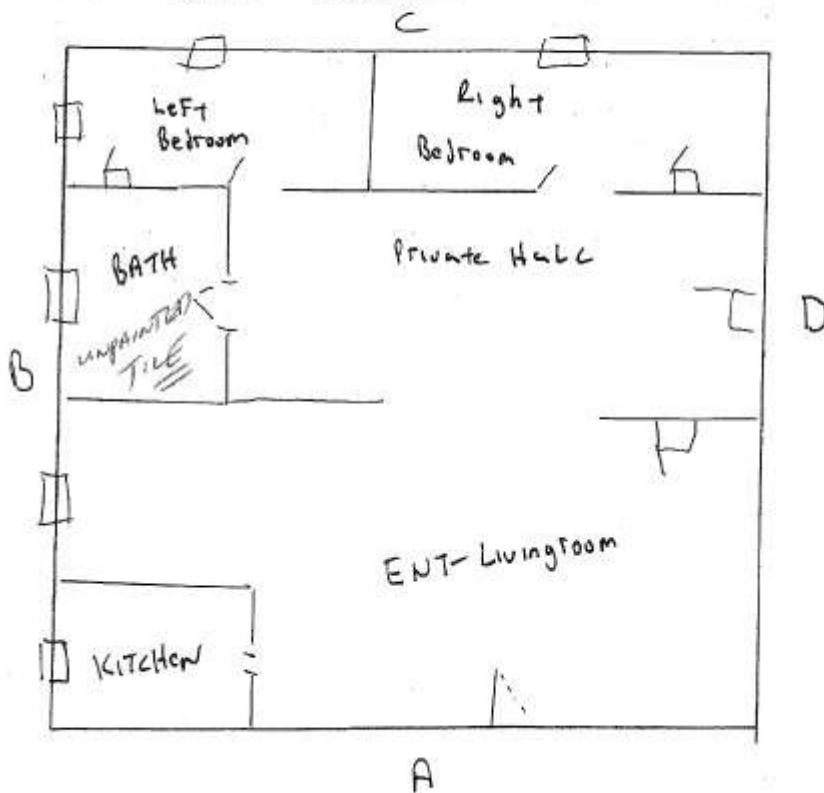
Floor Plan

the apartment entry, with sides B, C, and D following in a clockwise direction. The sides are noted on the floor plan and in the Data Charts.
