PROFESSIONAL BUILDING INSPECTORS

SUMMARY OF OUR FINDINGS

A site visit was conducted on January 9, 2009 at the above address. Our investigation of the building, confirmed by the attached laboratory samples, finds elevated levels of mold within the building such that remediation (cleaning) is recommended.

VISUAL INSPECTION

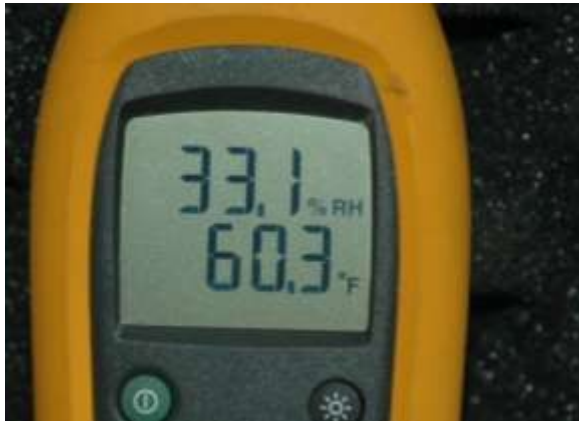
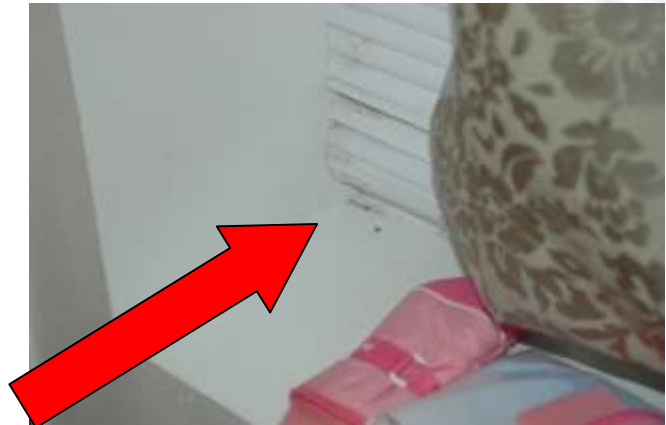
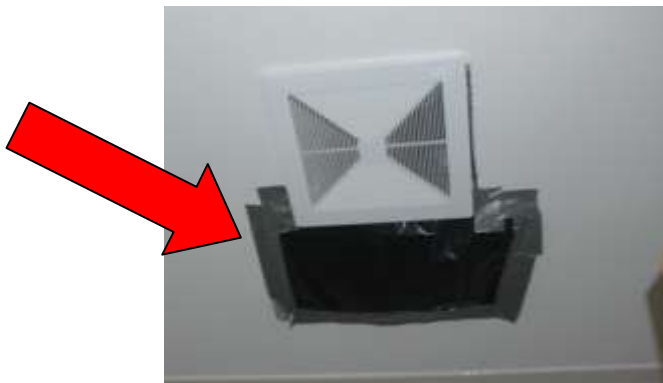
The apartment occupies the front half of the first floor of the building. The bedroom located in the front left corner of the home has some light staining on the exterior walls. There was no musty odor. The bathroom is located in the central portion of the building. There is an exhaust fan. The fan exhaust consists PVC pipe. This pipe is in excess of 25 feet and makes several turns as it courses through the building. Thermal imaging in the rear bedroom revealed a temperature anomaly consistent with a pipe leak which would be located below the baseboard radiator in the bathroom on the second floor.

In the **first floor front apartment bedroom** the amount of visible mold is less than 10 sq/ft and can be cleaned as follows:

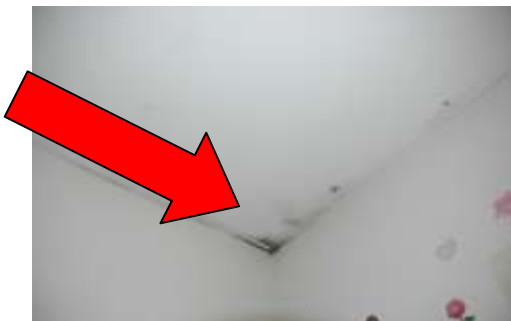
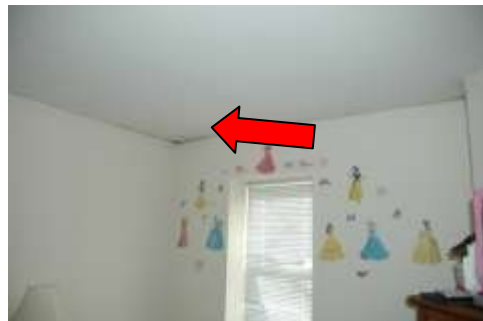
First floor rear apartment

Significant staining is seen on the ceiling along the outer wall of the home, the right rear corner of the home. The total square footage of visible mold at the time of the inspection was less than 10 ft.² Two adults and one child use this bedroom sleeping. The pattern of mold growth is suggestive of thermal bridging. There is no bathroom exhaust fan. There is no kitchen exhaust fan.

In the **first floor rear apartment bedroom** the amount of visible mold is less than 10 sq/ft. yet we suspect that there may be hidden mold on the back side of the sheetrock given the pattern of growth and the rapid return of staining following the cleaning efforts to date. It should be cleaned as follows:

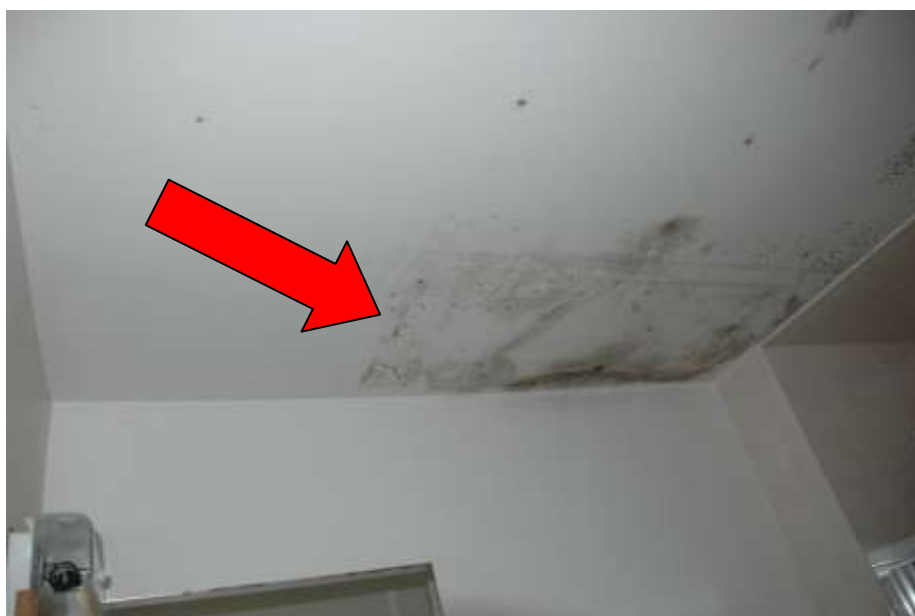
Second floor front apartment

Significant mold growth and staining is seen on the **bathroom ceiling**. Total square footage of visible mold is in excess of 30 ft.² but less than 100 ft.² There is no bathroom exhaust fan. Mold growth is seen behind the baseboard in the bathroom as well as behind the slant fin cover. There appears to be a leak from the baseboard heat in his location.

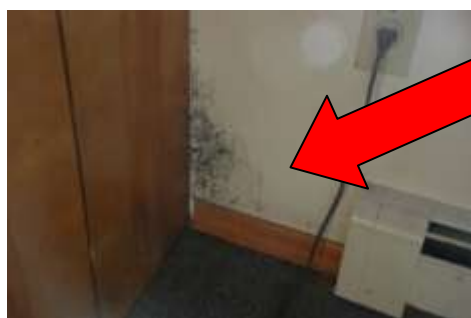
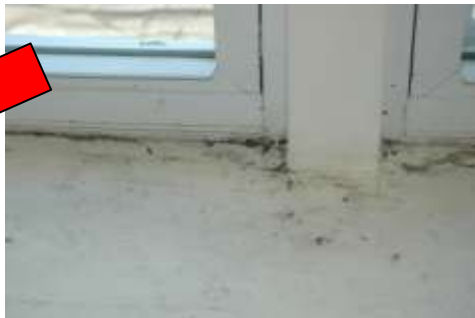
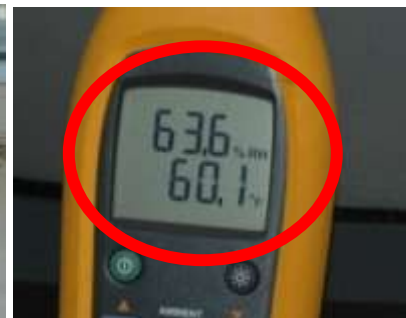
Visible mold growth was seen in the front bedroom along the window extension jams and at the base of the closet door. Large amounts of condensation were noted on the interior of the windows. Total square footage of visible mold in his bedroom is between 10 and 100 ft.²

In the second floor front apartment the tenant were home. Upon initial inspection to the front bedroom, where 2 adults were sleeping, we found the relative humidity **above 63%** with condensation on the cooler surfaces such as the windows and exterior walls.

Moisture content of the sheetrock was above 0.5% in those locations with visible mold growth indicating Dew Point condensation was occurring and saturating the building materials

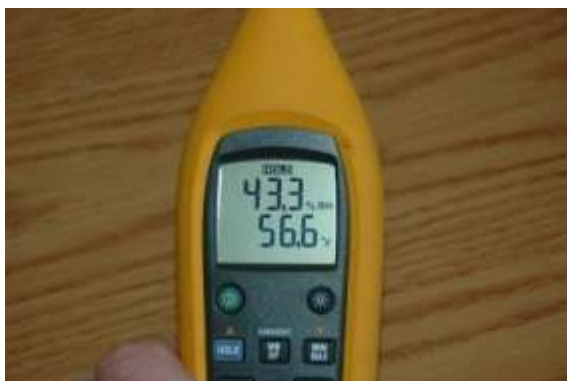
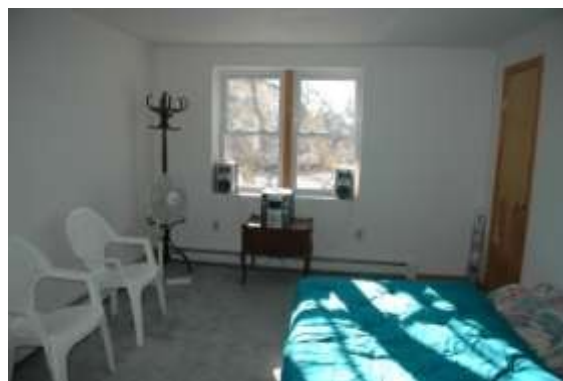
Second floor rear apartment

This apartment is furnished and carpeted but unoccupied. There is no visible mold growth or odor consistent with microbial VOC's. There is no bathroom exhaust fan. There is no kitchen.

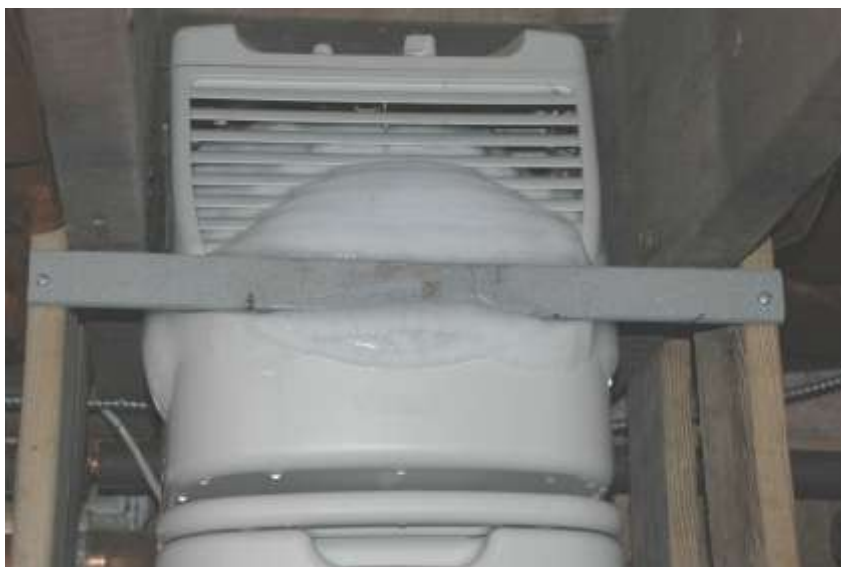
Basement

Efflorescence is noted on some of the exterior foundation walls. This is suggestive of water intrusion. There is a standalone dehumidifier for the rear portion of the basement. The unit was iced up and frozen at the time of the inspection. There was no visible mold in the basement or odors suggestive of active mold growth, VOC's.

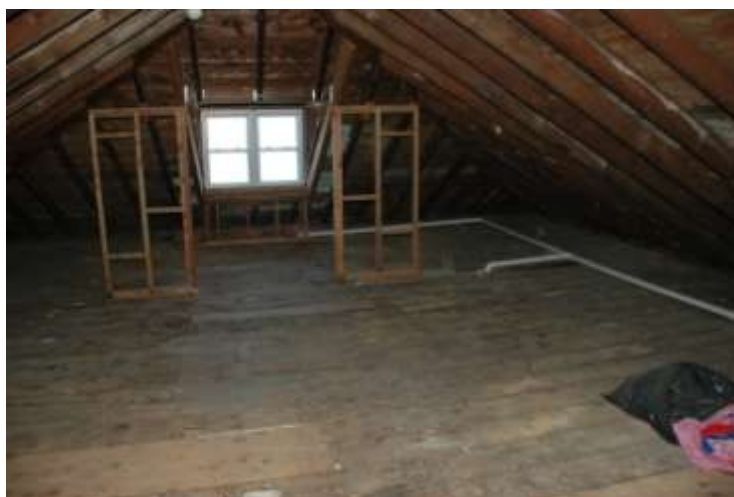
Attic

The attic space is empty, unfinished. Access is via a hallway hatch. There is mild mold growth noted on the under surface of the wood particularly at the lower portions of the sheathing where the sheathing is closest to the eaves. The attic is well ventilated at this time.

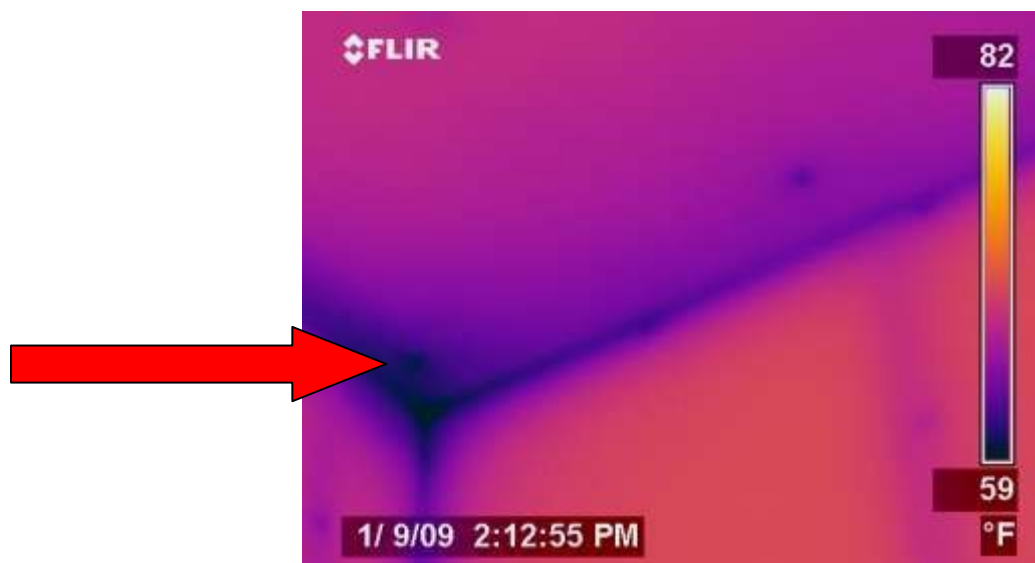
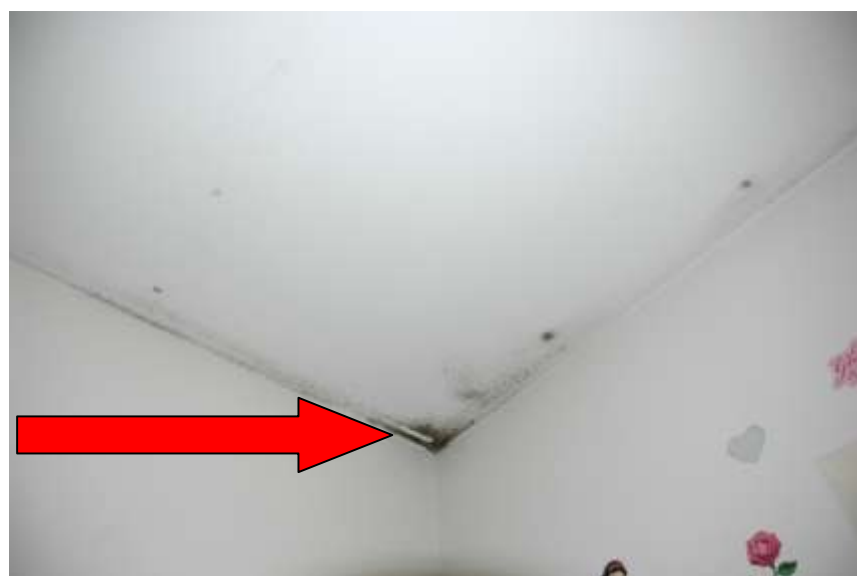
THERMAL IMAGING

We utilized a FLIR infra red camera during the inspection. The below thermal images show a pattern of thermal bridging in the building with mold growth on the cooler surfaces. **Just like a cold drink will bead up and sweat during the summer months, the humid air in the various rooms from the occupants breathing, cooking, and bathing is condensing on the coldest portions of the building.**
