PROFESSIONAL BUILDING INSPECTORS

SUMMARY OF OUR FINDINGS

A site visit was conducted on January 9, 2009 at the above address. Our investigation of the building, confirmed by the attached laboratory samples, finds elevated levels of mold within the building such that remediation (cleaning) is recommended.

VISUAL INSPECTION

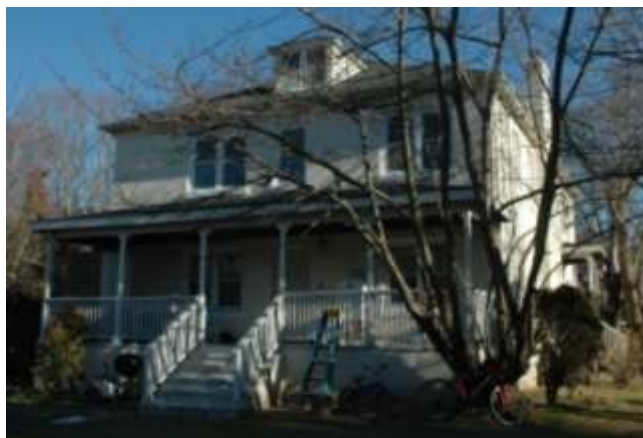
FIRST FLOOR FRONT APARTMENT

The apartment occupies the front half of the first floor of the building. The bedroom located in the front left corner of the home has some light staining on the exterior walls. There was no musty odor. The bathroom is located in the central portion of the building. There is an exhaust fan. The fan exhaust consists PVC pipe. This pipe is in excess of 25 feet and makes several turns as it courses through the building. Thermal imaging in the rear bedroom revealed a temperature anomaly consistent with a pipe leak which would be located below the baseboard radiator in the bathroom on the second floor.
